Diving Master Plan for Malta

Dive Site Report I 4: Cirkewwa – Marfa Point Mellieha

Version I: December 2010

DIVE SITE REPORT 14: CIRKEWWA – MARFA POINT (MELLIEHA)

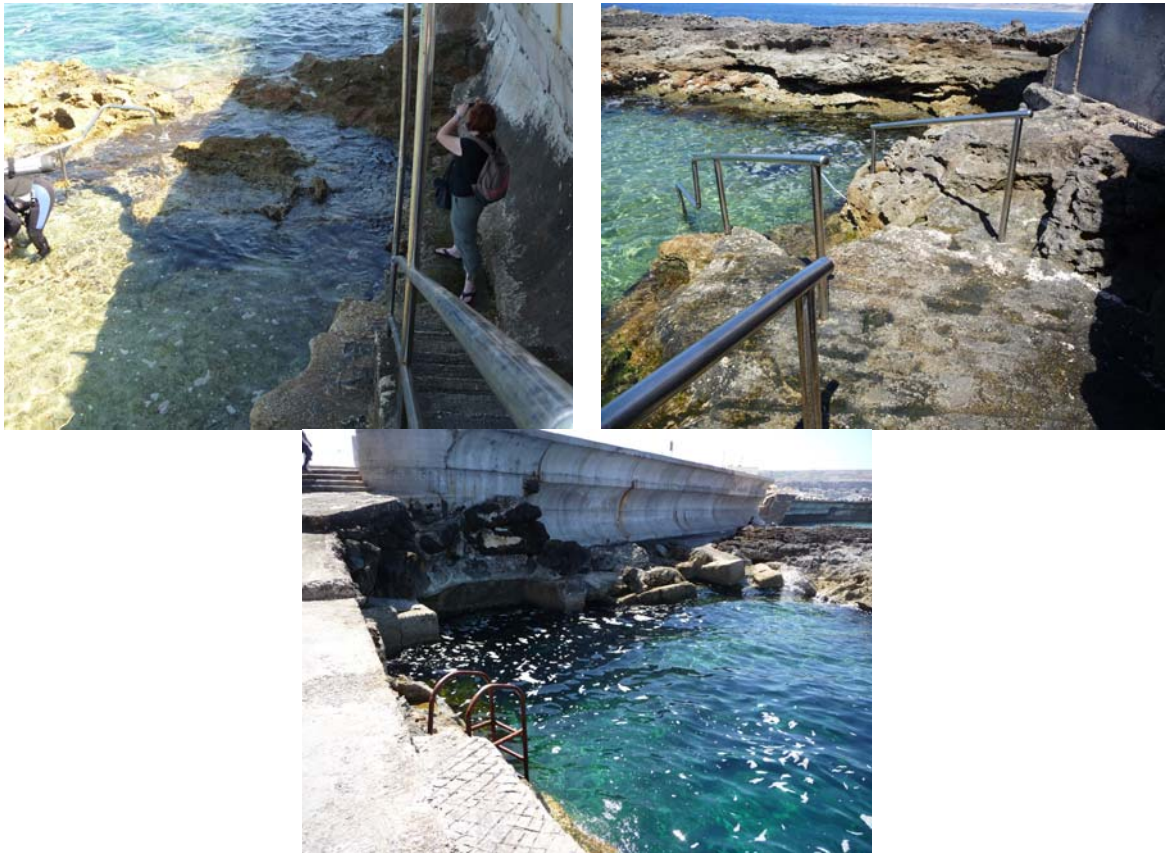
Figure 2: Access point E1, E2, E3

2. Cirkewwa – Marfa Point can be accessed mainly from Marfa road. There are three entry / exit points. All three are highly accessible; the first two access points include stairs and a ramp both equipped with stainless steel hand rails whilst the final access point next to the lighthouse has a ladder (see **Figure 2**).

10. Entry point E2 is located further towards the lighthouse. A rock-cut slope (with worn out rock-cut steps) and a central stainless steel railing leads divers to the water's edge. Stainless steel hand rails help divers access and exit the sea.
11. Entry point E3 is located just below the Marfa Point lighthouse. Divers access the sea either by using the ladder or through a giant stride over the rocks.
12. Litter was encountered during the site visits.
13. **Figure 4** shows the location of the existing facilities.
14. Further details on this dive site are available in the Data Card in **Annex I**.

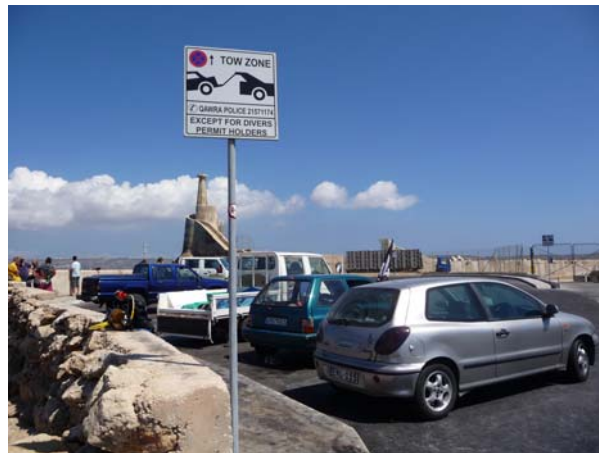
Figure 3: Divers' parking

8. The site offers facilities for divers. The informal parking area reserved for dive trucks is located within a few metres of the access points (see **Figure 3**). Safety infrastructure, such as railings, is present. Replacing CCTV cameras that are not functioning can increase the site's security. The nearest fuel filling station is found at Mellieha, more than 2 km away from the site. The closest dive centre is located at the nearby Paradise Bay Hotel.
9. Entry point E1 is located to the south of Marfa Point. It consists of a flight of steps equipped with a stainless steel railing; additional stainless steel hand rails allow an easy walk over the rocks to access the water.
