Diving Master Plan for Malta

Dive Site Report 19: Exiles Sliema

Version 1: December 2010

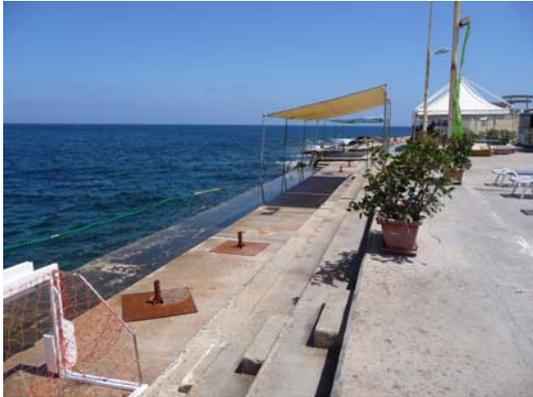
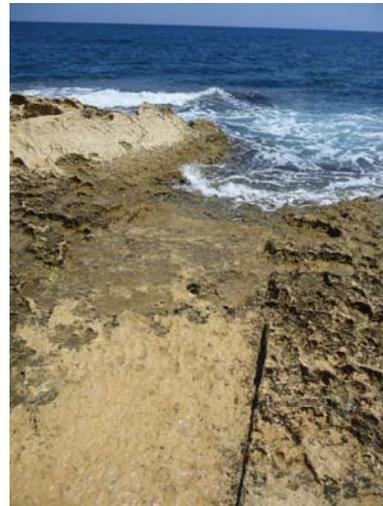
Figure 2: Access point E1 and E2

2. Access to Exiles is through a narrow road on the left of the road that leads from St Julian's to Sliema. There are two entry points E1 and E2. E1 is accessed from concrete footsteps and a concrete platform (where there is a ladder) whilst E2 is mainly accessible over bare rock (See **Figure 2**).

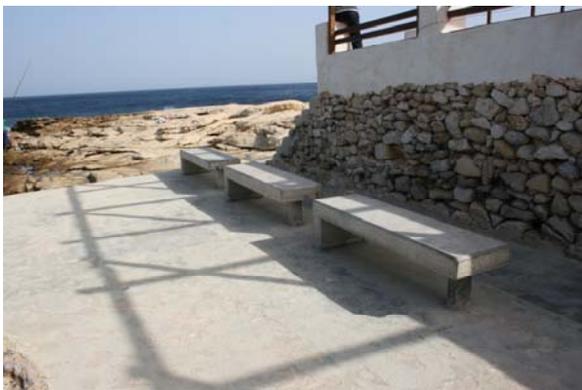
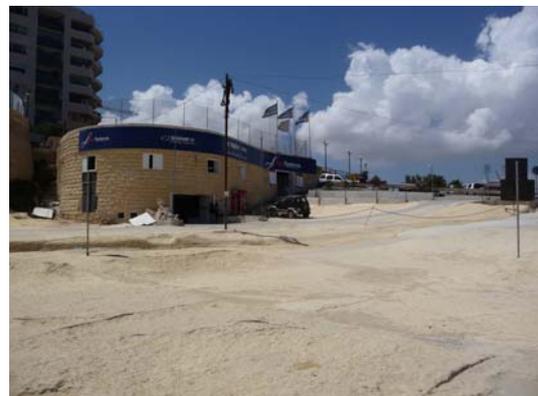
Figure 4: Existing facilities

8. The site offers various facilities for divers. The formal parking area is just 50m and 100m away from the access points E1 and E2 respectively (See **Figure 3**). The nearest fuel filling station is found at Balluta, around 1km away from the site. The nearest dive centre is located on site (See **Figure 4**).

9. Entry point E1 is over a concreted platform and access to the water is via a ladder. In the case of E2, one has to walk over bare rock and some concreted paths in order to arrive to the sloping entry point.
10. **Figure 5** shows the location of the existing facilities.
11. Further details on this dive site are available in the Data Card in **Annex I**.

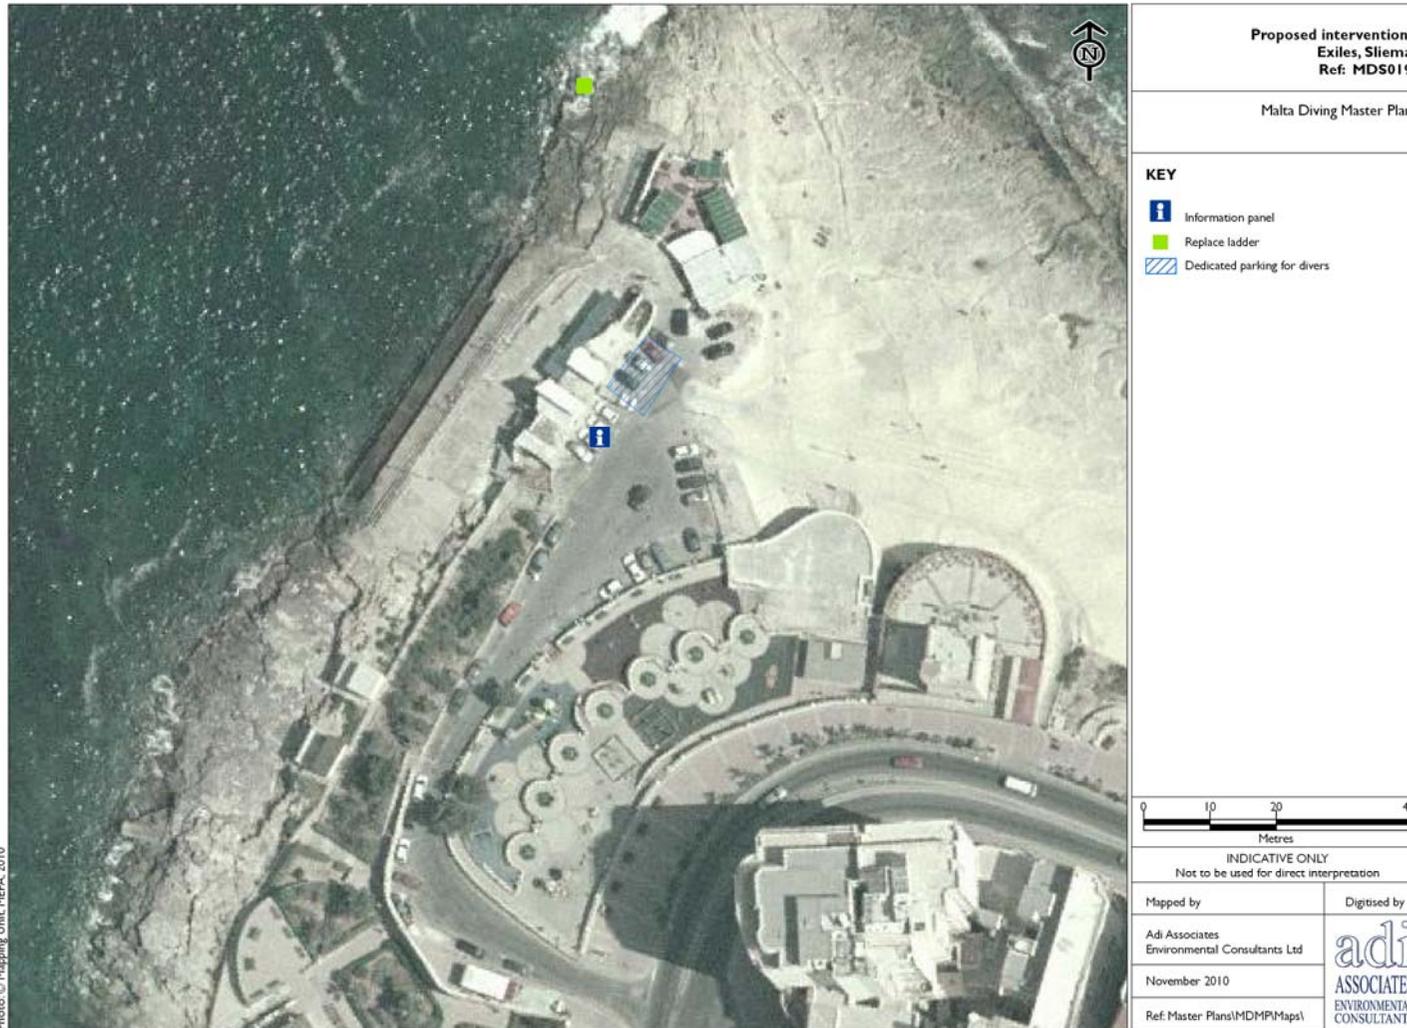
Figure 6: Proposed interventions

12. Some minor interventions are required at this site to improve it for diving purposes. Most measures seek to remove hazards and improve safety and security, or to replace existing infrastructure with proper diver-friendly facilities. It must be emphasised that most dive-related facilities can double-up for use by other recreational users, e.g. swimmers, etc. The proposed interventions are shown in **Figure 6** and include:

- The replacement of the ladder with a new stainless steel version;
- Provision of dedicated parking slots for divers; and
- Provision of signage.
