Diving Master Plan for Malta

Dive Site Report 18: Merkanti Reef Paceville

Version 1: December 2010

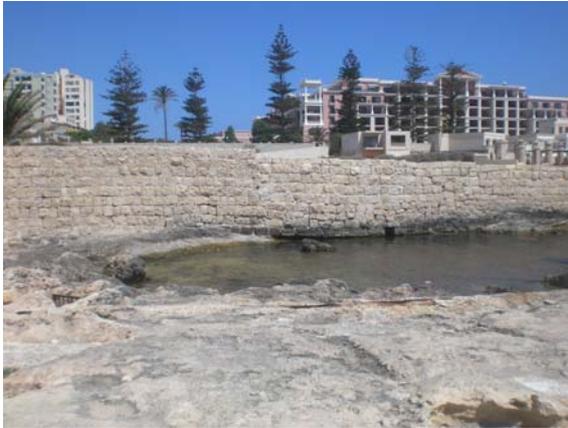
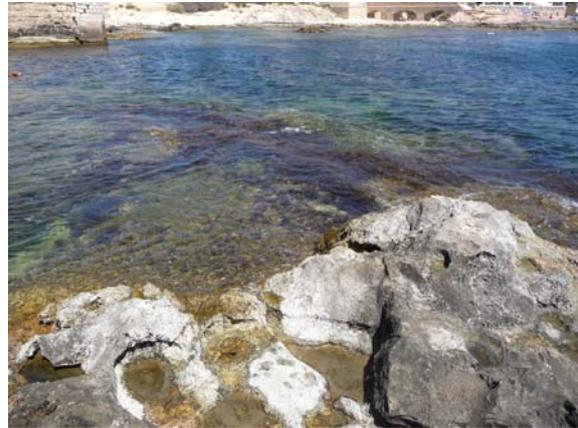
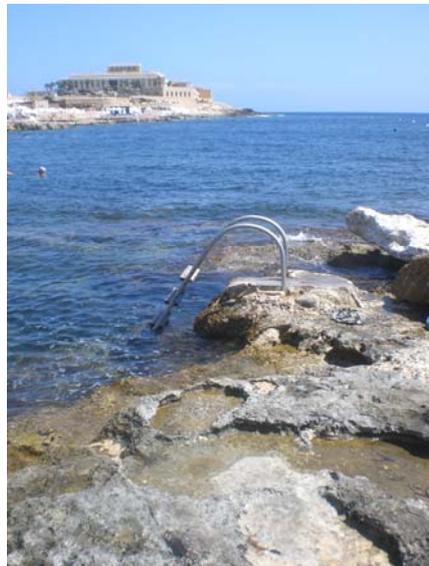
Figure 2: Access point E1 and E2

2. Merkanti Reef can be accessed from the road that leads from the Westin Dragonara Hotel to the Hilton Hotel. There are three entry points; two from the rocks and one from a ladder (see **Figure 2**).

9. Entry points E1 and E2 are located over bare rock whilst E3 is a ladder.
10. Large quantities of litter were encountered during site investigations.
11. **Figure 5** shows the location of the existing facilities.
12. Further details on this dive site are available in the Data Card in **Annex I**.

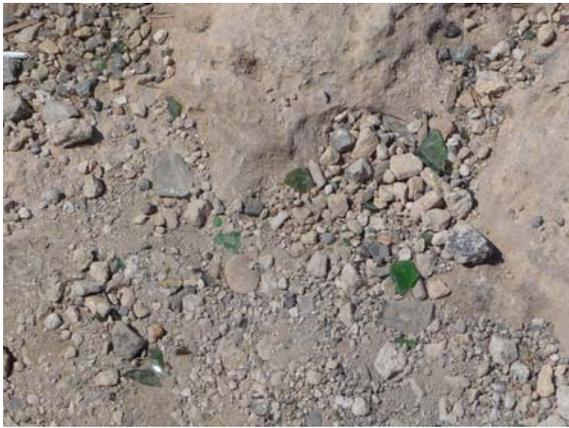
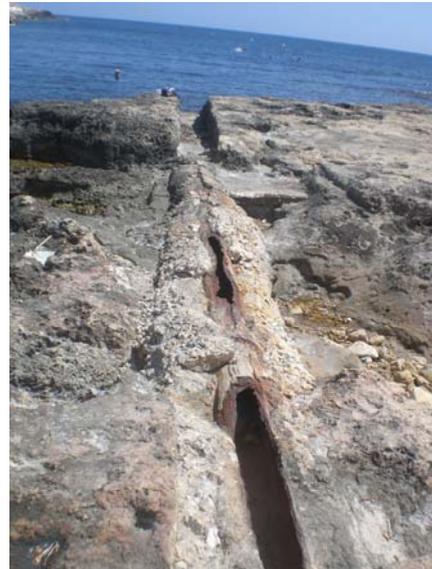
Figure 4: Safety hazards

8. The site does not offer many facilities for divers; however, the informal parking area is just 20m away from the access points (See **Figure 3**). Apart from the uneven surfaces there are other safety hazards mainly through scattered broken glass and a broken rusted pipe (see **Figure 3**). The nearest fuel filling station is found at Balluta, more than 2km away from the site. The closest dive centres are located at the Westin Dragonara Resort and the Hilton Hotel.

Hazard information	The main hazard was shattered glass. Large quantities of this broken glass were spread throughout the area. There was also a steel rusted pipe.				
--------------------	---	--	--	--	--

- Undertaking regular clean-ups of the sea bed (and providing adequate waste disposal containers on shore to promote safe and proper disposal of waste);
