## **Diving Master Plan for Malta**

### **Dive Site Report I: HMS Maori Il-Fossa, Marsamxett Harbour Valletta**

**Version I: December 2010**

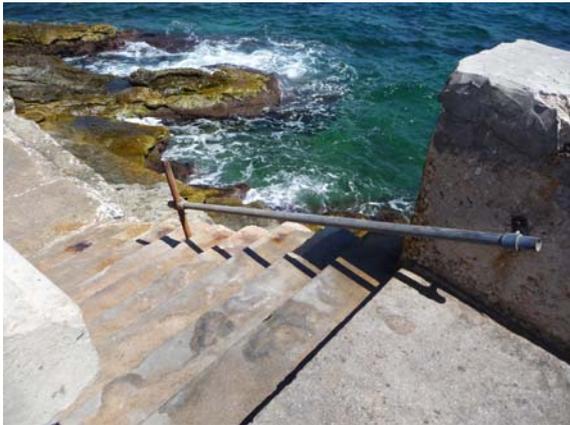
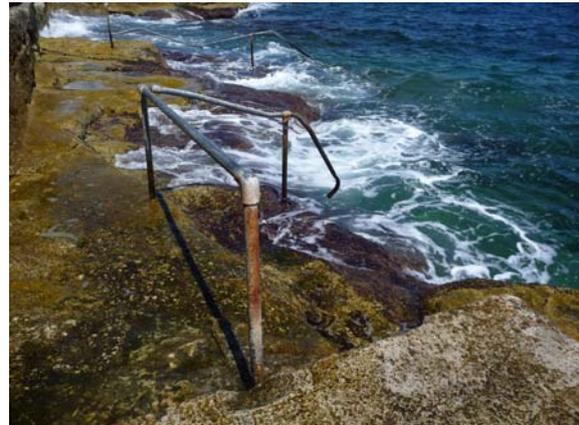
**Figure 2: Access point E1**

3. There are two access points to the dive site. The first (E1) is down concrete steps and over a concrete platform towards some rocks. Parts of the concrete surface and the rocks are very slippery. Steel railings are in place to help bathers and divers enter / exit the water. The railings are rather rusty; some are damaged (see **Figure 2**).

14. The first entry point (rocks) is located within 5m of the on-street parking area and can be quite slippery. The hand rails are rather rusty and damaged (or missing) in some parts.

18. A few hazards exist on site, mainly in the form of slippery surfaces and rusted metal structures. These should be removed. Broken hand rails should be replaced.

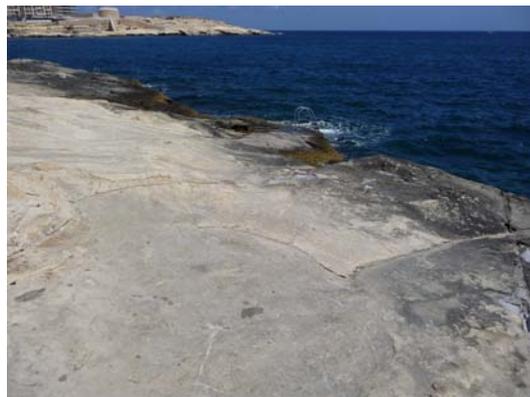
**Figure 3: Access point E2**

4. The second access (E2) is located beyond an informal parking area. A footpath over the rocks leads to the shoreline where one can access the sea using ladders or over a gentle slope (see **Figure 3**).

15. The second entry point (gentle slope / ladders) is located within 20m of the informal parking area and is an easy access point.
16. The site condition is generally acceptable, with only some small litter and animal waste encountered during the site inspection. Responses from divers however, indicate that both the shore and underwater areas are littered with rubbish. Provision of a few bins may help improve upon the situation as long as these are regularly serviced.

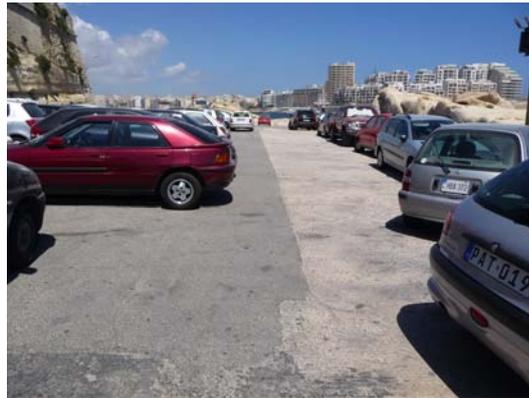
**Figure 4: The informal parking area**

5. The surrounding area is mainly used for car parking. The road along the shoreline is commonly lined with parked cars, mostly owned by people working in Valletta. An informal car park is located close to the dive site access point. This is heavily used, which makes parking for diving-related vehicles a problem (see **Figure 4**).
6. Two bars / restaurants are located close to the site.

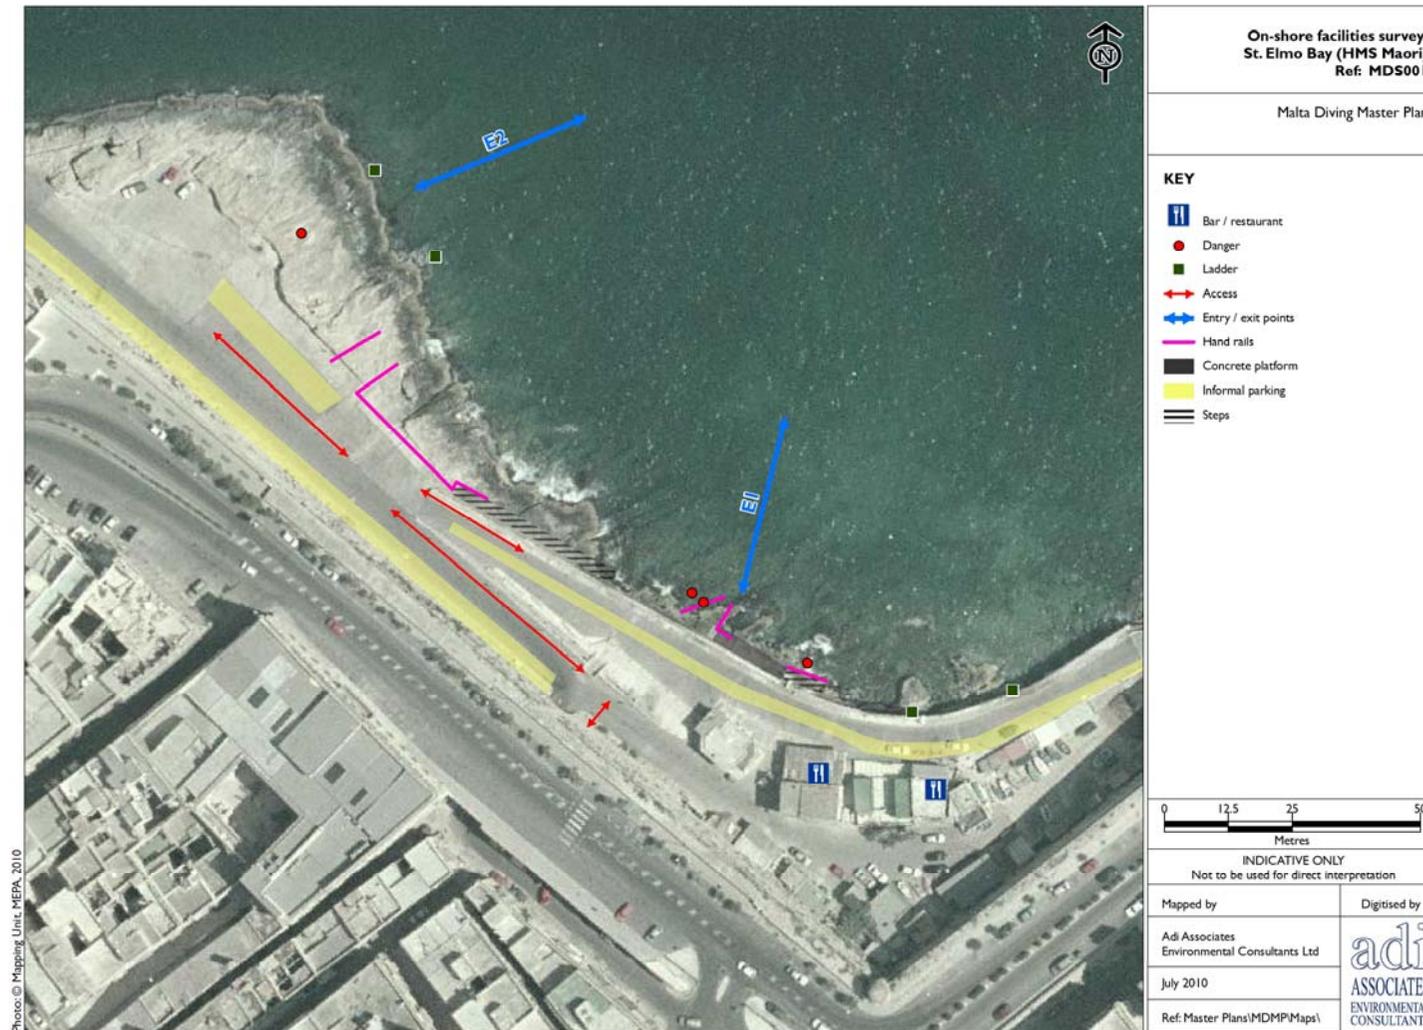
**Figure 5: Existing facilities**

13. The site does not offer many diving-related facilities. Although food and beverage outlets and informal parking are available on site, public telephones, a police station and fuel filling stations are located further away. The nearest dive centre is located in Gzira, more than 2 km away from the site.

17. A major issue of concern is theft and vandalism. Diver vehicles are often targeted which as a result, requires leaving somebody on-shore to guard the vehicle. Security cameras that are in place are not functional anymore.
