Diving Master Plan for Malta

Dive Site Report 19: Exiles Sliema

Version 1: December 2010

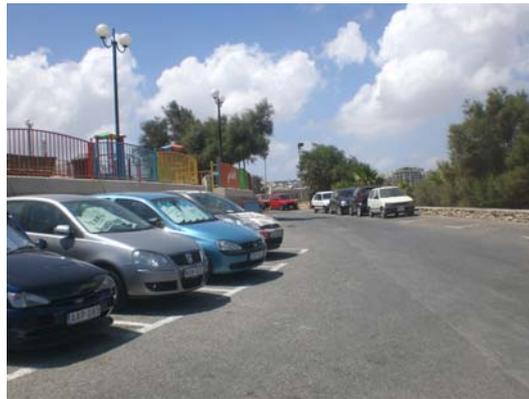
Figure 3: Parking facilities

8. The site offers various facilities for divers. The formal parking area is just 50m and 100m away from the access points E1 and E2 respectively (See **Figure 3**). The nearest fuel filling station is found at Balluta, around 1km away from the site. The nearest dive centre is located on site (See **Figure 4**).
