Diving Master Plan for Malta

Dive Site Report 18: Merkanti Reef Paceville

Version 1: December 2010

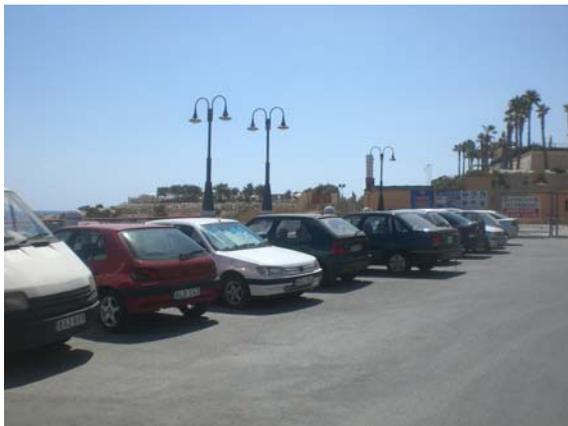
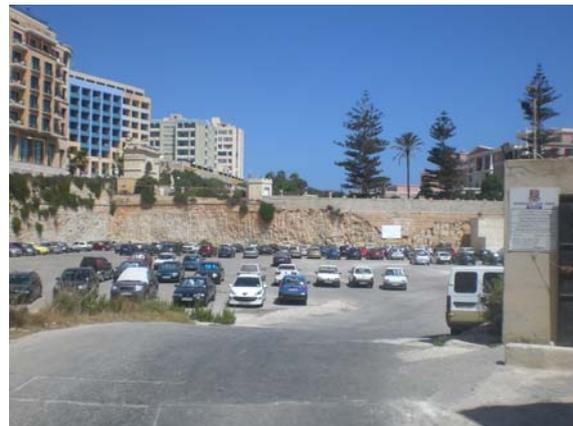
Figure 3: Parking facilities

8. The site does not offer many facilities for divers; however, the informal parking area is just 20m away from the access points (See **Figure 3**). Apart from the uneven surfaces there are other safety hazards mainly through scattered broken glass and a broken rusted pipe (see **Figure 3**). The nearest fuel filling station is found at Balluta, more than 2km away from the site. The closest dive centres are located at the Westin Dragonara Resort and the Hilton Hotel.

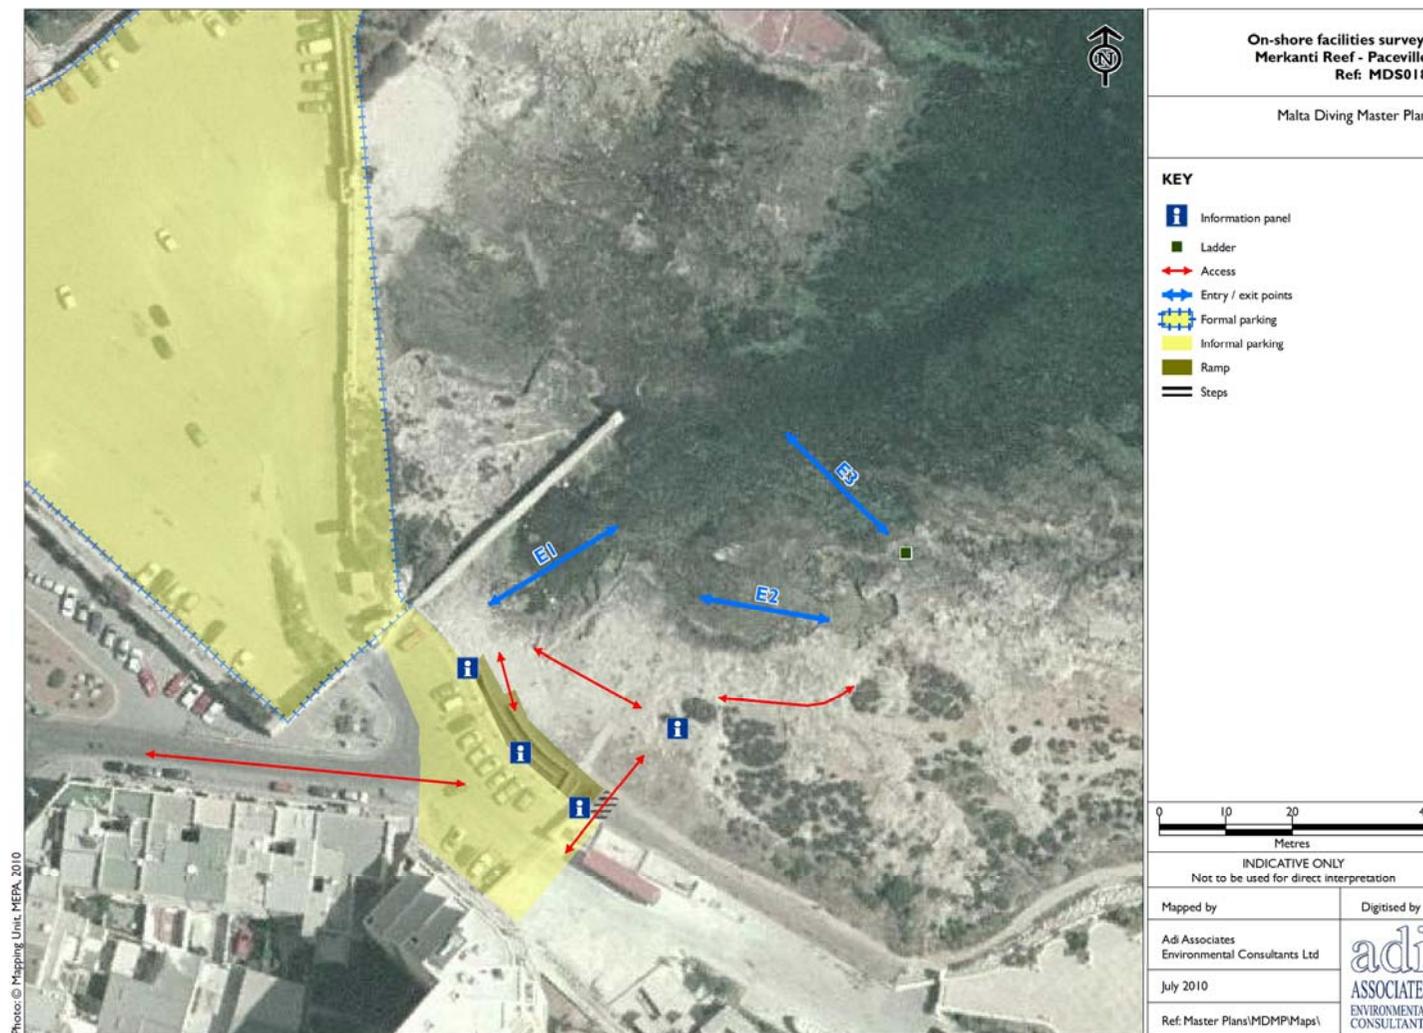
Figure 5: Existing facilities

9. Entry points E1 and E2 are located over bare rock whilst E3 is a ladder.
10. Large quantities of litter were encountered during site investigations.
11. **Figure 5** shows the location of the existing facilities.
12. Further details on this dive site are available in the Data Card in **Annex I**.
